**Flood Control Project Maintenance  
Levee Inspections**

## Maintenance Issue Types Only, Levee Inspection Report By Mile - Spring 2018

### Reclamation District No. 0070 Meridian

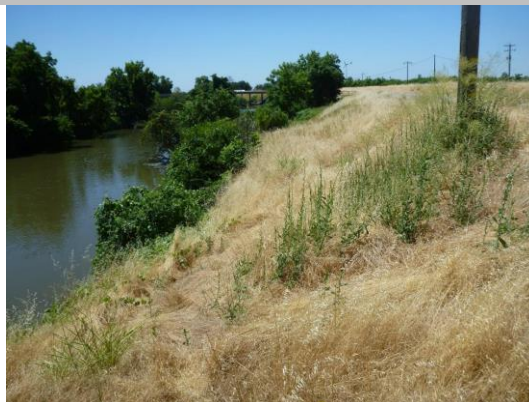
Photo 1 of 3 : LEVAL\_SP\_2018\_154\_1686.jpg

LM Start	0.76	Rating **	A/W	Issue No.	36
LM End	0.76	Issue Type +	Ma	Location *	
Category	Supplemental		GPS Latitude/Longitude		
			Start	End	
Item	2017 Storm Damage		39.145240 °	39.145240 °	
			-121.842650 °	-121.842650 °	
DWR ID	DWR_RD0070_01_f_2017_36				
Comment Code					
Inspector Comment					
Levee Evaluation Comments Description: Site ID No:154 Site Designation:RD 70-03 Repair Type: Erosion Rating:Area of Concern Field Date:7/17/2017 Notes:

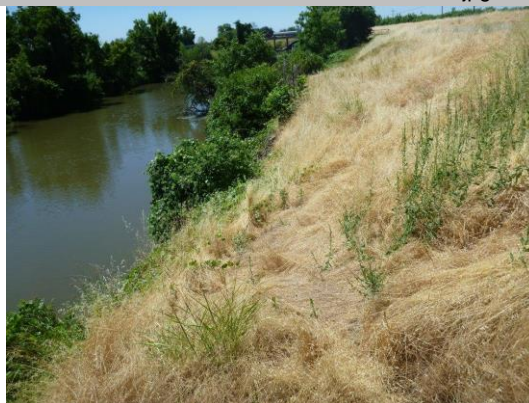
Photo 2 of 3 : LEVAL\_SP\_2018\_154\_1687.jpg

LM Start	0.76	Rating **	A/W	Issue No.	36 (cont)	
LM End	0.76	Issue Type +	Ma	Location *		
Category	Supplemental			GPS Latitude/Longitude		
				Start		End
Item	2017 Storm Damage			39.145240 °	39.145240 °	
				-121.842650 °	-121.842650 °	
DWR ID	DWR_RD0070_01_f_2017_36					
Comment Code						
Inspector Comment						
Levee Evaluation Comments						
Description:						
Site ID No:154						
Site Designation:RD 70-03						
Repair Type: Erosion						
Rating:Area of Concern						
Field Date:7/17/2017						
Notes:

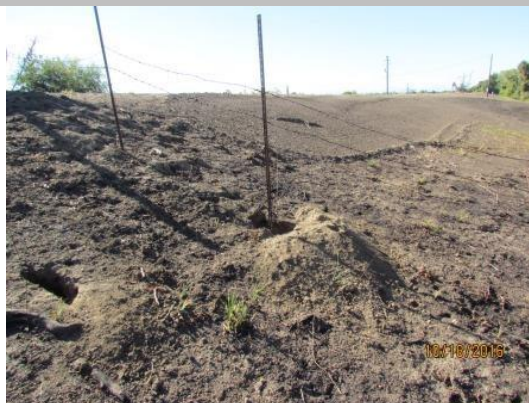
Photo 1 of 1 : SP\_2018\_RD0070\_29\_32\_20180305\_00009.jpg

LM Start	1.77	Rating **	M	Issue No.	32
LM End	1.77	Issue Type +	Ma	Location *	LS
Category	Earthen Levee			GPS Latitude/Longitude	
				Start	End
Item	Animal Control			39.151282 °	39.151282 °
				-121.855818 °	-121.855818 °
DWR ID	DWR_RD0070_01_f_2016_32				
Comment Code					
A1 : Exterminate rodents and backfill and compact or grout burrows.					
Inspector Comment

View of the rodent holes along the waterside slope.

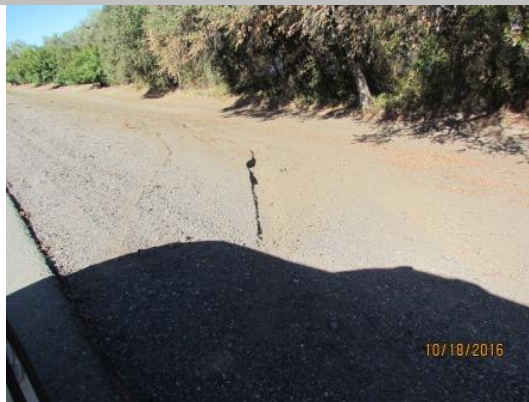
Photo 1 of 1 : SP\_2018\_RD0070\_29\_29\_20180305\_00004.jpg

LM Start	3.72	Rating **	M	Issue No.	29
LM End	3.72	Issue Type +	Ma	Location *	WS
Category	Earthen Levee			GPS Latitude/Longitude	
				Start	End
Item	Slope Stability			39.158183 °	39.158183 °
				-121.888397 °	-121.888397 °
DWR ID	DWR_RD0070_01_f_2016_29				
Comment Code					
S3 : Repair the levee slope damaged by vehicle traffic and prevent access where possible.					
Inspector Comment

View of the ruts along the waterside slope.

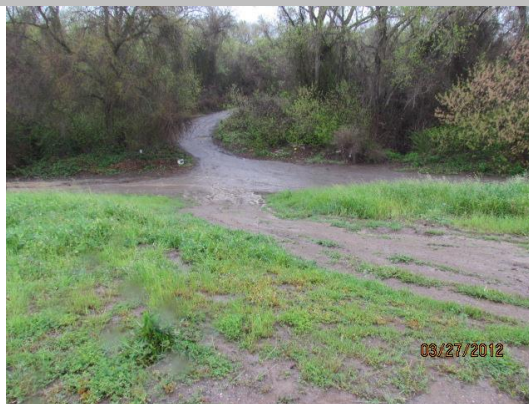
Photo 1 of 2 : SP\_2018\_RD0070\_29\_6\_20180305\_00001.jpg

LM Start	6.18	Rating **	M	Issue No.	6
LM End	6.18	Issue Type +	Ma	Location *	WS
Category	Earthen Levee			GPS Latitude/Longitude	
				Start	End
Item	Slope Stability			39.187481 °	39.187481 °
				-121.910852 °	-121.910852 °
DWR ID	DWR_RD0070_01_s_2012_6				
Comment Code					
S3 : Repair the levee slope damaged by vehicle traffic and prevent access where possible.					
Inspector Comment

View of vehicle erosion along the waterside slope.

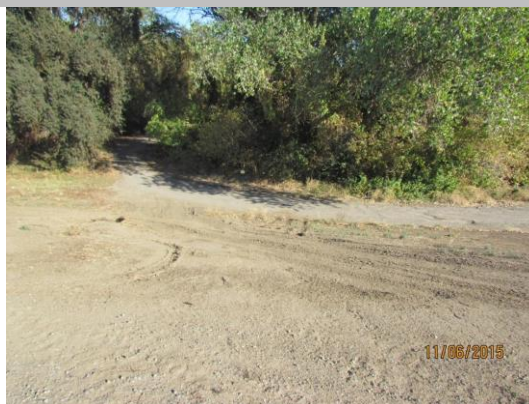
Photo 2 of 2 : SP\_2018\_RD0070\_29\_6\_20180305\_00002.jpg

View of the vehicle erosion along the waterside slope.

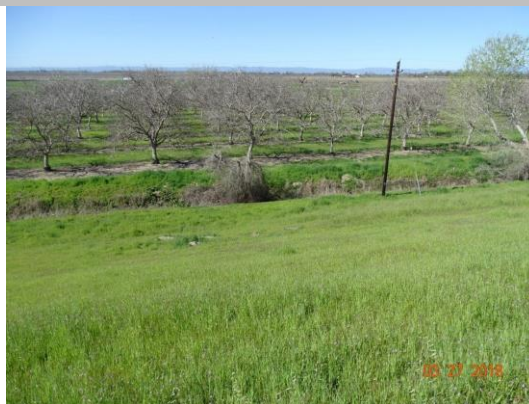
Photo 1 of 1 : SP\_2018\_RD0070\_29\_35\_20180403\_00076.jpg

LM Start	6.44	Rating **	M	Issue No.	35
LM End	6.44	Issue Type +	Ma	Location *	LS
Category	Earthen Levee			GPS Latitude/Longitude	
				Start	End
Item	Animal Control			39.190897 °	39.190897 °
				-121.912713 °	-121.912713 °
DWR ID	DWR_RD0070_01_s_2018_35				
Comment Code					
A3 : No rodents visible, but rodent burrows visible; need to backfill and compact or grout burrows.					
Inspector Comment					
Repair the rodent holes along the landside slope.

View of the rodent holes along the landside slope.

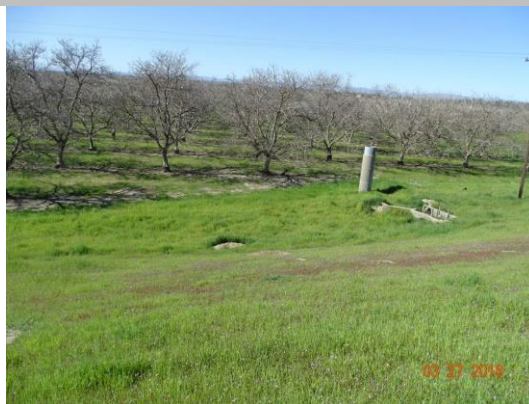
Photo 1 of 1 : SP\_2018\_RD0070\_29\_40\_20180403\_00077.jpg

LM Start	6.57	Rating **	U	Issue No.	40
LM End	6.57	Issue Type +	Ma	Location *	LS
Category	Earthen Levee			GPS Latitude/Longitude	
				Start	End
Item	Animal Control			39.192283 °	39.192283 °
				-121.914388 °	-121.914388 °
DWR ID	DWR_RD0070_01_s_2018_40				
Comment Code					
A3 : No rodents visible, but rodent burrows visible; need to backfill and compact or grout burrows.					
Inspector Comment					
Repair the rodent holes along the landside slope.

View of rodent holes along the landside slope.

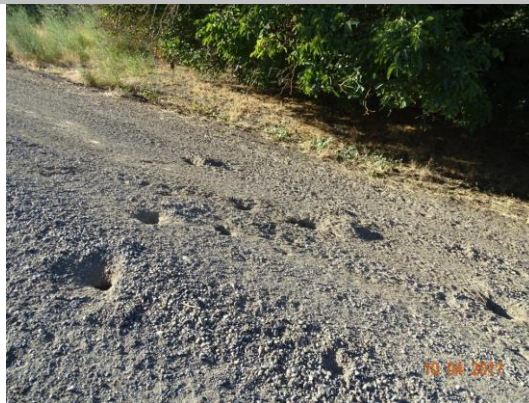
Photo 1 of 1 : SP\_2018\_RD0070\_30\_76\_20180305\_00019.jpg

LM Start	3.46	Rating **	M	Issue No.	76
LM End	3.46	Issue Type +	Ma	Location *	WS
Category	Earthen Levee			GPS Latitude/Longitude	
				Start	End
Item	Animal Control			39.155008 °	39.155008 °
				-121.921905 °	-121.921905 °
DWR ID	DWR_RD0070_02_f_2017_76				
Comment Code					
A1 : Exterminate rodents and backfill and compact or grout burrows.					
Inspector Comment					
Repair the rodent holes along the waterside slope.

View of the rodent holes along the waterside slope.

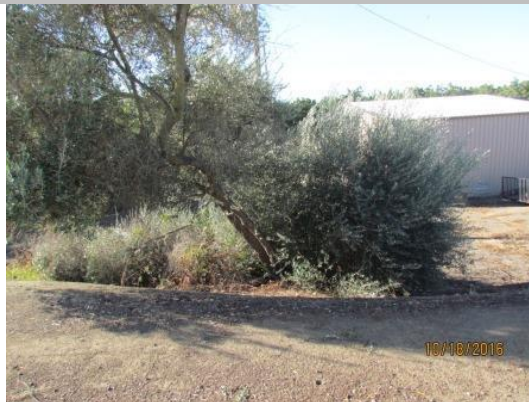
Photo 1 of 1 : SP\_2018\_RD0070\_30\_54\_20180305\_00006.jpg

LM Start	4.95	Rating **	M	Issue No.	54
LM End	4.95	Issue Type +	Ma	Location *	LS
Category	Earthen Levee			GPS Latitude/Longitude	
				Start	End
Item	Trim / Thin Trees			39.142016 °	39.142016 °
				-121.926214 °	-121.926214 °
DWR ID	DWR_RD0070_02_f_2016_54				
Comment Code					
T1 : Trim trees to at least five feet above ground level.					
Inspector Comment

View of the trees blocking visibility.

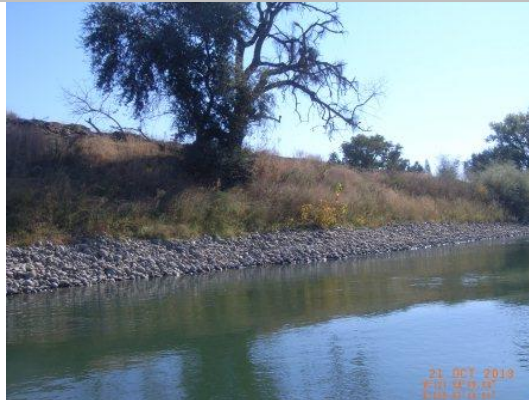
Photo 1 of 1 : SP\_2018\_RD0070\_30\_2\_20180305\_00002.jpg

LM Start	8.10	Rating **	M	Issue No.	2
LM End	8.23	Issue Type +	Ma	Location *	WS
Category	Supplemental			GPS Latitude/Longitude	
				Start	End
Item	2015 USACE Erosion Survey, DRAFT			39.122459 °	39.120684 °
				-121.910121 °	-121.909152 °
DWR ID	DWR_RD0070_02_s_2016_2				
Comment Code					
Inspector Comment					
1997 - Critical Site - Erosion of cobble site on outside of a bend. Failure caused by erosion of a material from behind the cobbles and cobbles rolling down the slope. Failure is just above the toe levee. Some repairs had been done at the upstream end. 2004 - Some minor new erosion at the top of the berm. 2005 - Trees look okay and the downstream end has some new rock repair. Site is no longer critical. 2006 - No longer critical, some repairs. 2015: No observed changes. [2015 Site ID: SAC_130-0_L]

USACE 2013 Photo #1

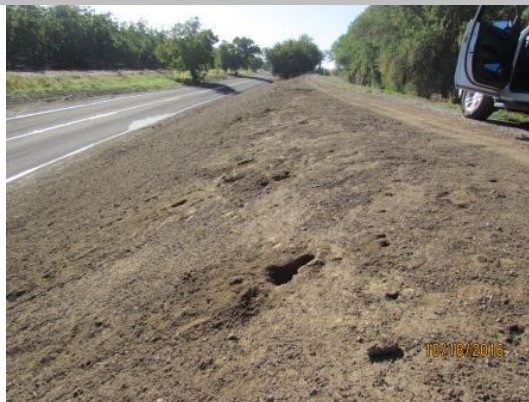
Photo 1 of 1 : SP\_2018\_RD0070\_30\_61\_20180305\_00010.jpg

LM Start	9.28	Rating **	M	Issue No.	61
LM End	9.28	Issue Type +	Ma	Location *	LS
Category	Earthen Levee			GPS Latitude/Longitude	
				Start	End
Item	Animal Control			39.107285 °	39.107285 °
				-121.900753 °	-121.900753 °
DWR ID	DWR_RD0070_02_f_2016_61				
Comment Code					
A3 : No rodents visible, but rodent burrows visible; need to backfill and compact or grout burrows.					
Inspector Comment

View of the rodent holes along the landside slope.

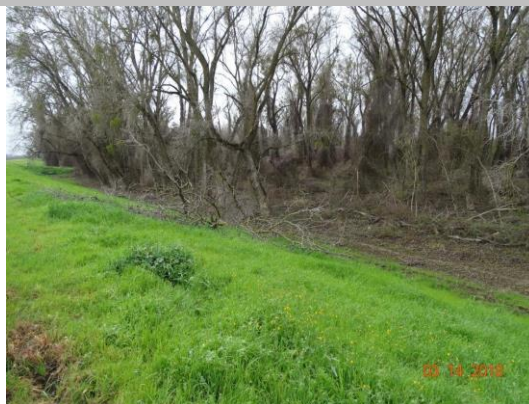
Photo 1 of 1 : SP\_2018\_RD0070\_30\_48\_20180402\_00128.jpg

LM Start	11.07	Rating **	M	Issue No.	48
LM End	11.07	Issue Type +	Ma	Location *	WS
Category	Earthen Levee			GPS Latitude/Longitude	
				Start	End
Item	Encroachments			39.086098 °	39.086098 °
				-121.889988 °	-121.889988 °
DWR ID	DWR_RD0070_02_s_2018_48				
Comment Code					
TR : Tree or limb					
Inspector Comment					
Remove the tree from the waterside slope and toe.

View of the tree along the waterside slope and oe

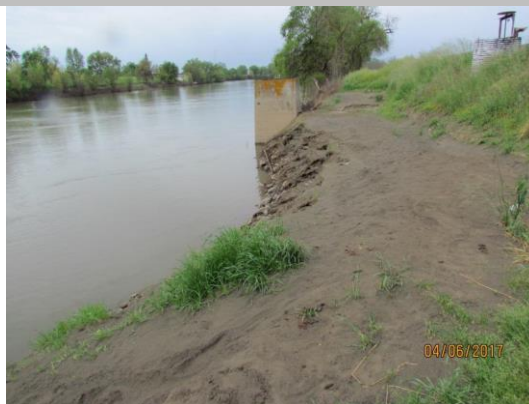
Photo 1 of 1 : SP\_2018\_RD0070\_30\_72\_20180305\_00015.jpg

LM Start	13.82	Rating **	A/W	Issue No.	72
LM End	13.82	Issue Type +	Ma	Location *	WS
Category	Earthen Levee			GPS Latitude/Longitude	
				Start	End
Item	Erosion / Bank Caving			39.068370 °	39.068370 °
				-121.862763 °	-121.862763 °
DWR ID	DWR_RD0070_02_s_2017_72				
Comment Code					
E2 : Schedule repair of erosion site prior to the next inspection.					
Inspector Comment					
Repair the erosion along the waterside slope.

View of the erosion along the waterside slope.

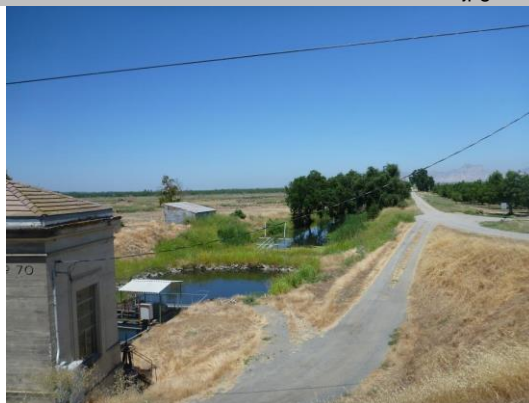
Photo 1 of 3 : LEVAL\_SP\_2018\_152\_1717.jpg

LM Start	13.83	Rating **	A/W	Issue No.	75
LM End	13.83	Issue Type +	Ma	Location *	
Category	Supplemental			GPS Latitude/Longitude	
				Start	End
Item	2017 Storm Damage			39.068190°	39.068190°
				-121.862700°	-121.862700°
DWR ID	DWR_RD0070_02_f_2017_75				
Comment Code					
Inspector Comment					
Levee Evaluation Comments					
Description:					
Site ID No:152					
Site Designation:RD 70-01					
Repair Type: Erosion					
Rating:Area of Concern					
Field Date:7/17/2017					
Notes: bank slope erosion around a drainage pipe/box

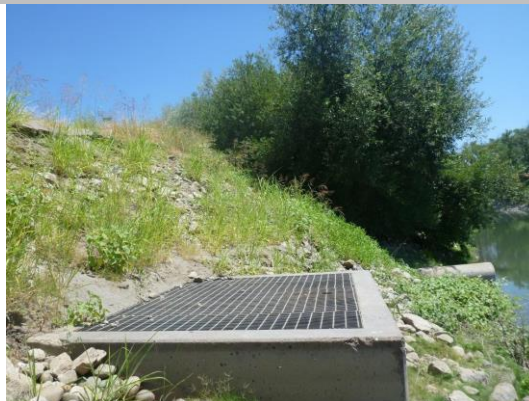
Photo 3 of 3 : LEVAL\_SP\_2018\_152\_1730.jpg

LM Start	13.83	Rating **	A/W	Issue No.	75 (cont)	
LM End	13.83	Issue Type +	Ma	Location *		
Category	Supplemental			GPS Latitude/Longitude		
				Start	End	
Item	2017 Storm Damage			39.068190°	39.068190°	
				-121.862700°	-121.862700°	
DWR ID	DWR_RD0070_02_f_2017_75					
Comment Code						
Inspector Comment						
Levee Evaluation Comments						
Description:						
Site ID No:152						
Site Designation:RD 70-01						
Repair Type: Erosion						
Rating:Area of Concern						
Field Date:7/17/2017						
Notes: bank slope erosion around a drainage pipe/box

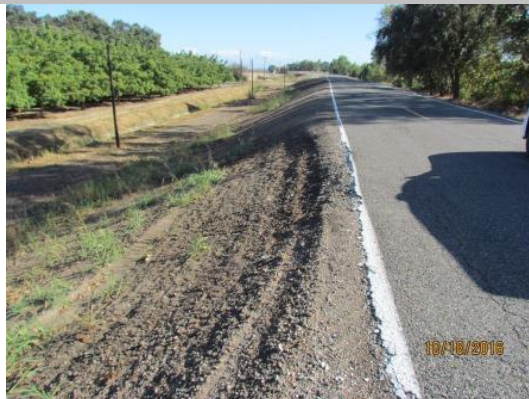
Photo 1 of 1 : SP\_2018\_RD0070\_30\_66\_20180305\_00013.jpg

LM Start	14.14	Rating **	M	Issue No.	66
LM End	14.14	Issue Type +	Ma	Location *	LS
Category	Earthen Levee			GPS Latitude/Longitude	
				Start	End
Item	Slope Stability			39.069849 °	39.069849 °
				-121.857267 °	-121.857267 °
DWR ID	DWR_RD0070_02_f_2016_66				
Comment Code					
S1 : Repair slope instability.					
Inspector Comment

View of slope instability along the landside slope.
